# SPILL INVESTIGATION ONGOING IN GRANVILLE, NY

The New York State Departments of Environmental Conservation (DEC) and Health (DOH) are providing this community update regarding the July 5, 2024, spill of firefighting foam at the Saint-Gobain Facility in Granville, Washington County.

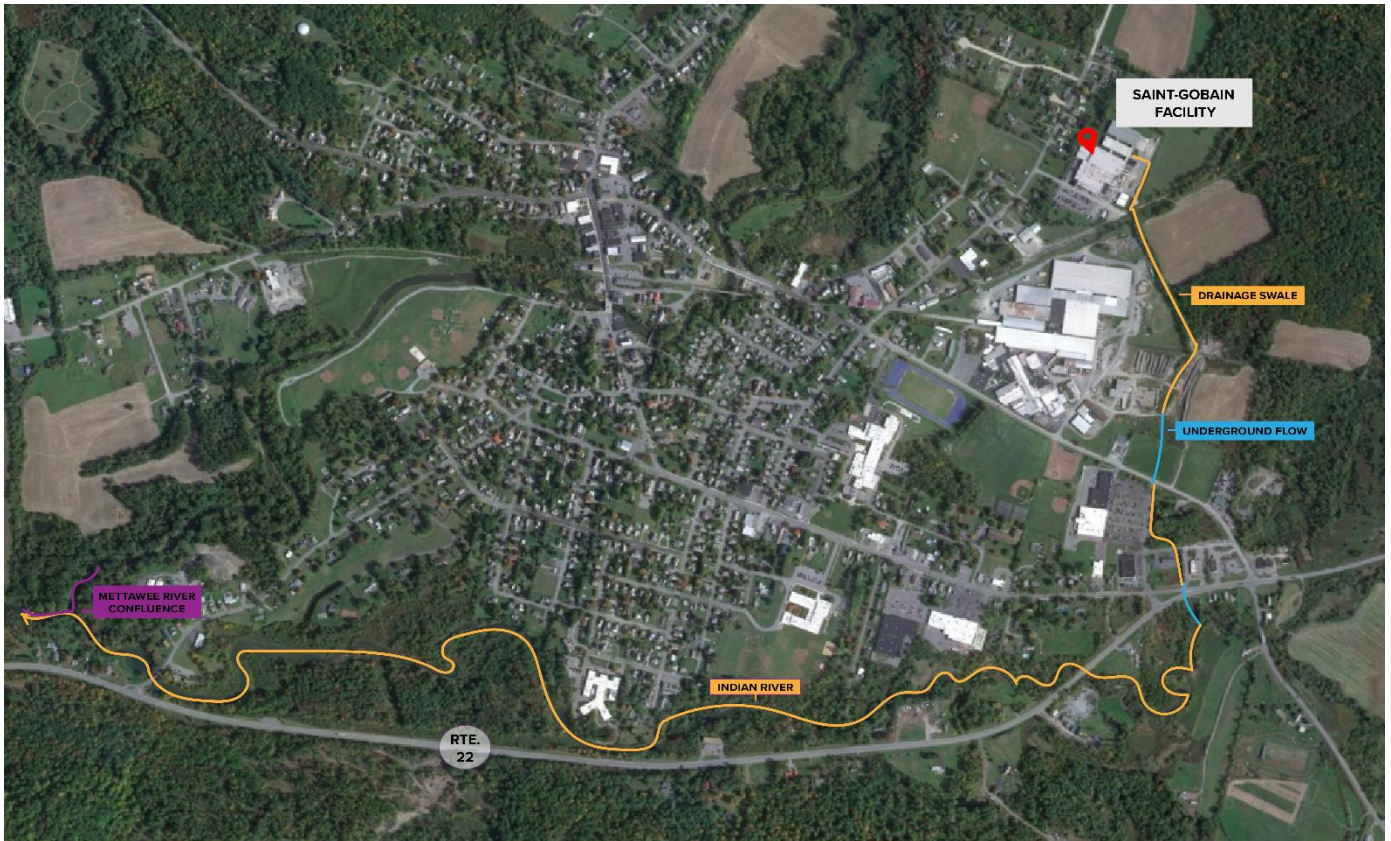
Map depicting the flow of the spill from the Saint-Gobain facility, through drainage swales and underground culverts to the Indian River.

Orange flow path is area of spill investigation, avoid fishing, swimming or recreating in these areas.

- Drainage Swales, Indian River
- Underground Flow
- Mettawee River

the affected area (see map on page 3) will be evaluated to assess if testing is recommended to determine if the spill has affected their well. Where testing is recommended, those property owners will be contacted by the State to discuss the testing. At this time, DOH has no evidence to suggest that property owners on private wells cannot safely drink and use their water.

While the spill is investigated and out of an abundance of caution, DOH recommends that people avoid fishing, swimming, and recreating in the section of the Indian River north (downstream) of the Route 149 bridge to the confluence with the Mettawee River (approximately 0.25 miles north of the Mettawee Street bridge). This includes the pool immediately downstream of the Mettawee Street bridge. Signs are posted in affected areas to notify the public. The Mettawee Village Park and swimming area is upstream of the confluence and was not affected by this spill.
